**EVALUATING THE PERFORMANCE OF TiN COATING ON PM MILLING
CUTTERS USED IN THE MANUFACTURING OF BANDSAWS**

Mohammed Sarwar^{a,*}, Julfikar Haider^a, Martin Persson^b, Håkan Hellbergh^b

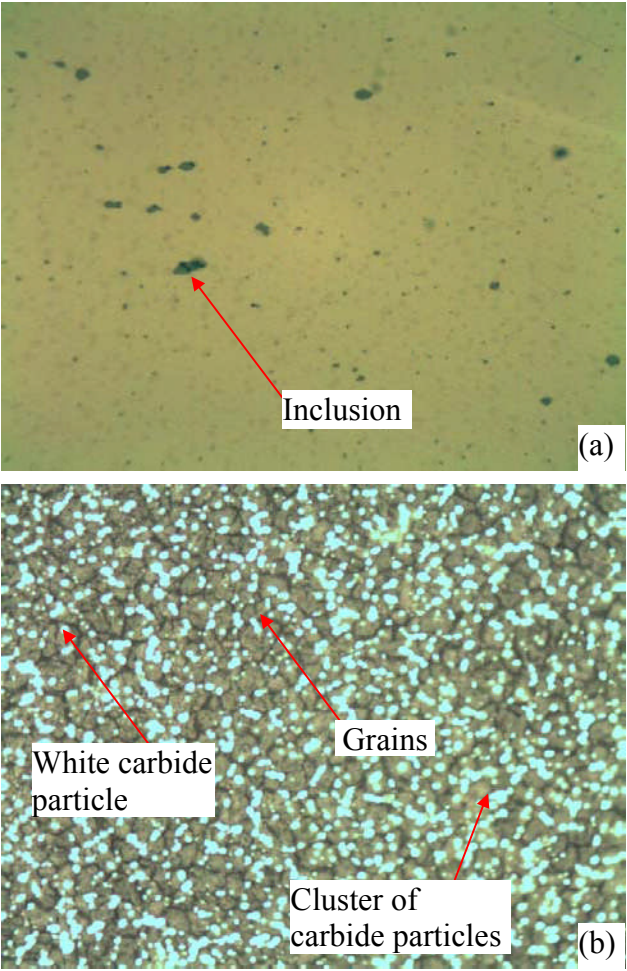
Figure Number: 3

The hardness of cutter substrate (PM REX 54 HSS) varied from 840-860 HV_{1.0} (equivalent to 65.5 - 66 Rc), which was in the given specification. The surface morphology before etching under the light optical microscope showed non-metallic inclusions dispersed in the material (Fig. 3a). These inclusions were believed to be small sulphide particles, which could result in machinability and grindability benefits with no adverse effect on toughness. In the etched sample, optical microscope revealed smaller grains (25 grains across 0.127 mm diameter circle) with uniformly distributed round carbide particles (Fig. 3b), which will provide required strength at the cutting edges of the cutter.

Fig. 3. Surface morphology of the PM Rex 54 HSS material (a) without etching and (b) after etching (Mag. 1000×)

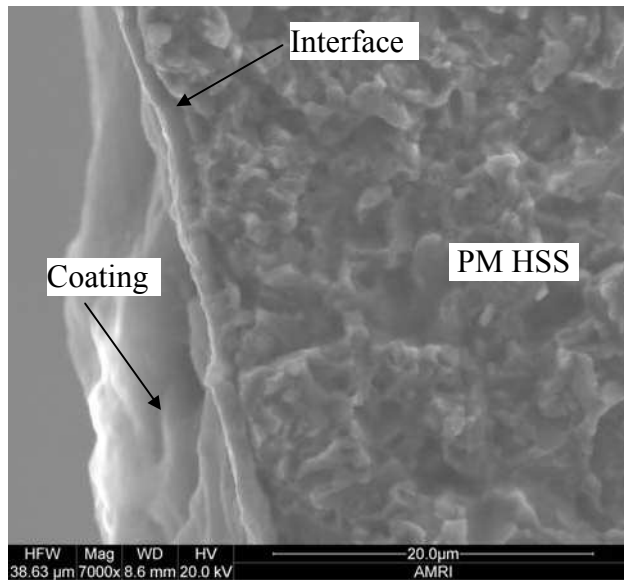
Figure Number: 4

Under SEM, the coating fracture morphology appeared very densely packed with no distinguishable feature, which indicated good quality of coating (Fig. 4). After examining the interface between the coating and the substrate, it appeared that the coating was also well adhered. However, the thickness of the coating varied between 2 µm - 4 µm around cutting edges of milling cutter.

Fig. 4. SEM image of TiN coating fractured morphology on a milling cutter tooth

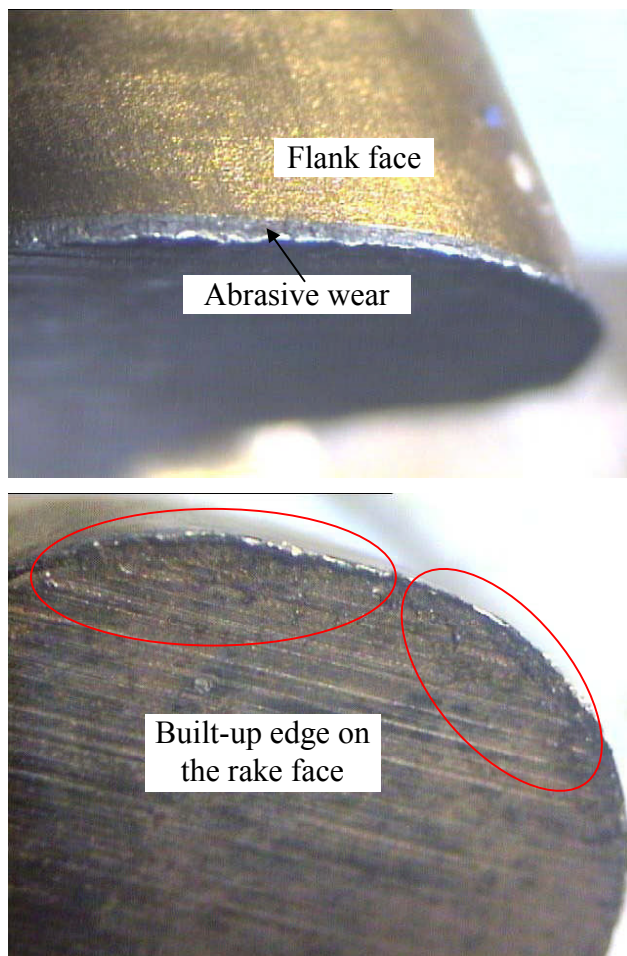
Figure Number: 5

Edge radius of an uncoated cutter at new condition was very small ($\sim 7\text{ }\mu\text{m}$ - $9\text{ }\mu\text{m}$), which was typical of grinding process. On the other hand, edge radius of a coated cutter at new condition was slightly higher ($9\text{ }\mu\text{m}$ - $12\text{ }\mu\text{m}$) than that of uncoated cutter due to the coating on the cutting edges. At new condition both the coated and uncoated edges were sharp with no burr. After examining many cutters, flank wear and notch wear were identified as the principal mode of wear in both coated and uncoated cutters. The abrasive wear and adhesive wear with the detachment of built-up edges were the governing mechanisms of the flank wear as shown in Fig. 5. No macro flaking of the TiN coating from the flank face was observed. The built-up

Fig. 5. Wear characteristics in a coated milling cutter tooth under optical microscope

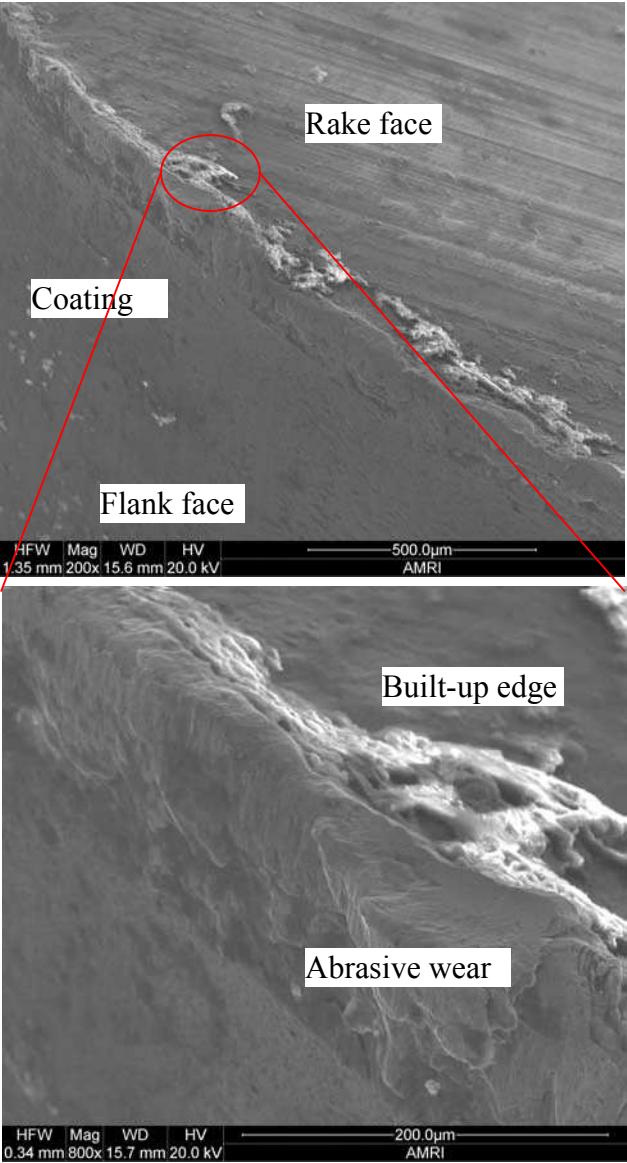
Figure Number: 6

edge and abrasive wear were more clearly revealed under SEM (Fig. 6). Similar abrasive and adhesive wear were also observed in the uncoated cutters. Notch wear at the crossover point on the flank face was quite common in small tooth form cutters. Notch wear was not observed in big tooth form cutters and full form cutters (roughing flute followed by finishing flute). In many coated cutters notch wear was significantly lower. It was established that notch wear at the crossover point on the flank face was related to the tooth tip burr in the bandsaw. In the uncoated and small tooth form cutters, strong burrs are left in the flank face after regrinding due to material flow from the grinding action. In the coated and big tooth form cutters, cutting edges are sharp with no burrs left in the flank face after regrinding. The coating could provide hard surface to prevent any material flow as burr after regrinding. Furthermore, TiN coating on milling cutter also offered more confidence in operating at higher feeds and speeds. The premature failure of the cutter generally occurred due to the rubbing with the band, hard join-up welding in the band or thinner flute width at the end of the cutter life.

Fig. 6. Wear characteristics in a coated milling cutter tooth under SEM

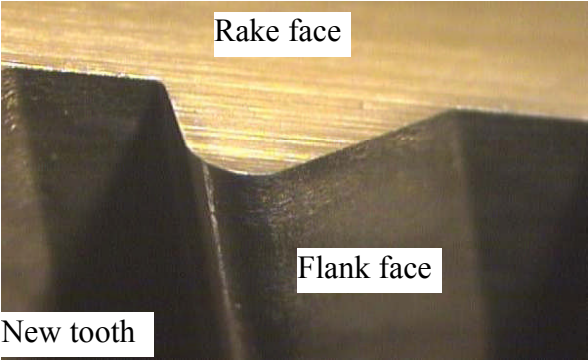
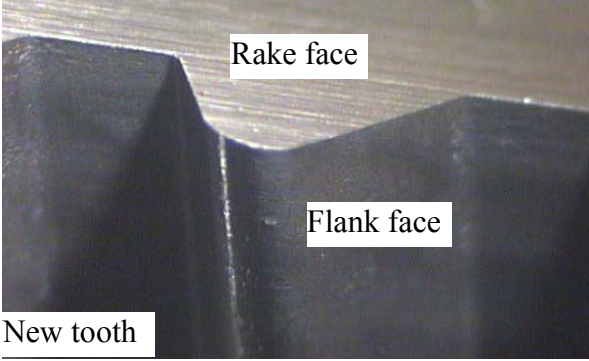
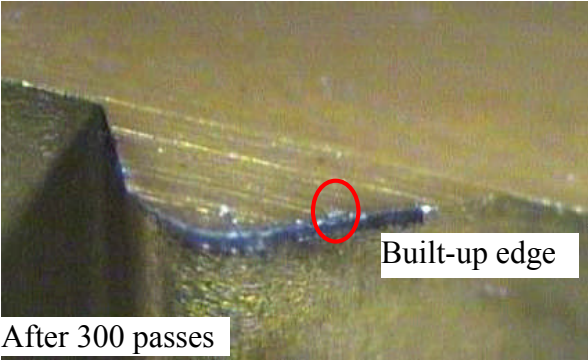
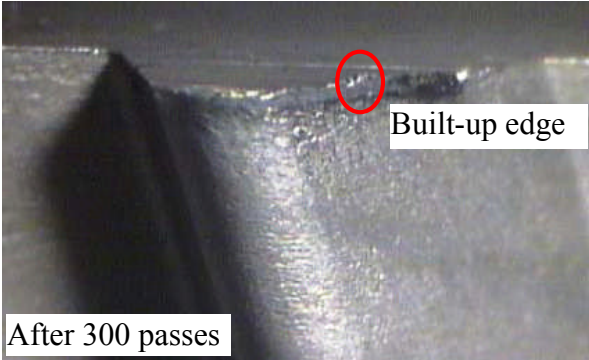
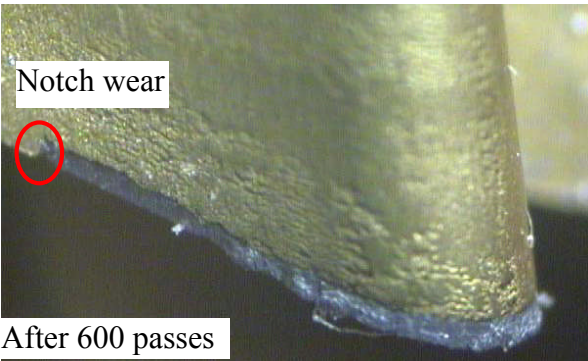
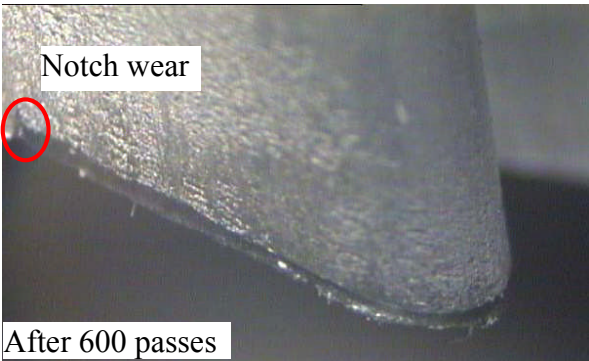
Figure Number: 7

Cutting edges of the new coated and uncoated teeth of the half-length coated cutter were sharp with no burr. After 300 milling passes coating started to break off from the flank face and adhesive wear with built-up edge developed in both coated and uncoated teeth. Flank wear and adhesive wear with the built-up edge also increased after 600 passes. In some flutes the built-up edges broke off along with the cutter material both in coated and uncoated teeth. Notch wear at the crossover point on the flank face of the cutter were also visible in both coated and uncoated teeth. **Fig. 7** shows the coated and uncoated teeth at new condition, after 300 milling passes and after 600 milling passes. Flank wear in the coated teeth after 600 passes was in the range of 0.10 mm to 0.22 mm whereas, the flank wear in the uncoated teeth was in the range of 0.13 mm to 0.35 mm when measured using image analysis software. The measurement was also verified in few selected teeth by profiling them across the flank face. Flank wear in the coated and uncoated teeth of the half-length coated cutter was in the range of 0.17 mm to 0.20 mm and 0.25 mm to 0.34 mm respectively when measured by the Contacer profilometer.

Fig. 7. Coated and uncoated teeth of the half-length coated milling cutter at new condition, after 300 passes and after 600 passes.

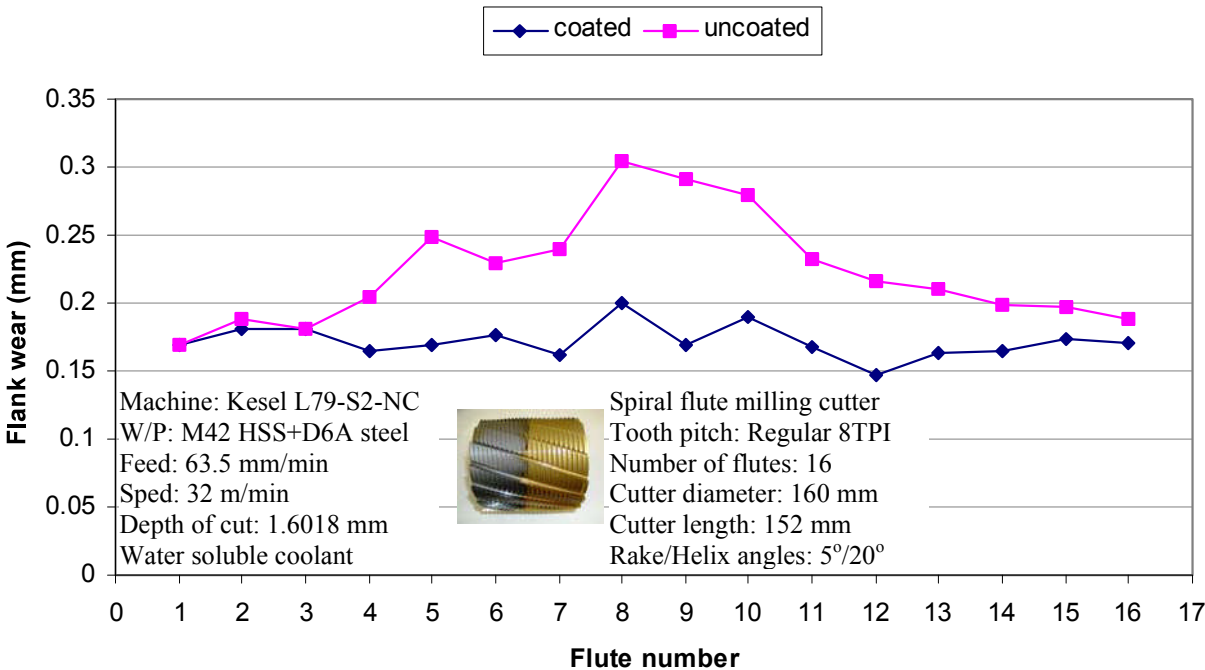
Figure Number: 8

Flank wear in a selected coated tooth and uncoated tooth of all 16 gashes were measured on three different positions on the flank face. **Fig. 8** shows the amount of flank wear at one position near the crossover point and the percentage of reduction of flank wear by TiN coating. The coating reduced the flank wear up to 40% compared to the uncoated teeth. However, the flank wear in the coated teeth was not always consistent. In some flutes flank wear in the coated teeth were equal to the wear in the uncoated teeth. Complex cutting action by the multipoint milling cutters compared to single point cutting tools, lack of manufacturing

accuracy of the cutter teeth and variation in the quality of the coating on complex geometry of every tooth could be responsible for this kind of variation. It should be noted for multi-point tools, such as milling cutters, the overall performance is determined by the combination of cutting edge, rake face and gullet characteristics. Furthermore, it is important that all teeth are manufactured to the same specification in order to maximise the tool performance and life, as a multi-point tool is only as good as its weakest tooth [5]. A total systems approach combining tool materials, tool design, manufacturing quality, surface preparation and appropriate coating characteristics is necessary to achieve beneficial performance from the coated multipoint cutting tools.

Fig. 8. Flank wear plot of the coated and uncoated teeth in all 16 flutes of the half-length coated milling cutter

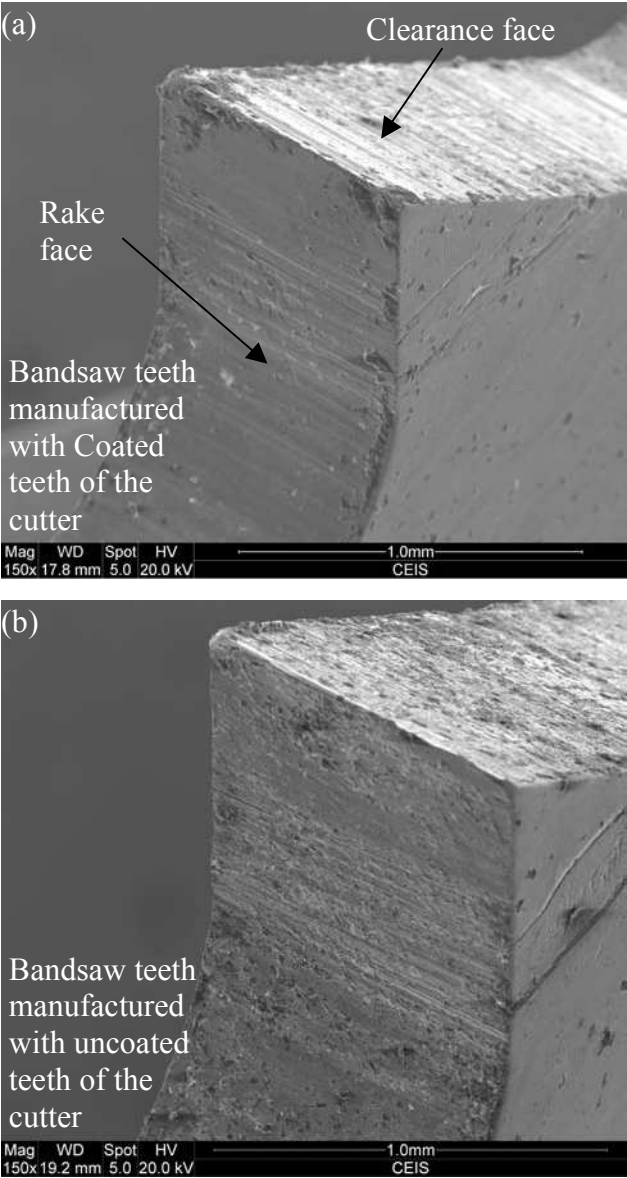
Figure Number: 9

Fig. 9 shows that under SEM a better surface characteristics can be observed in the bandsaw teeth manufactured by coated teeth of the milling cutter. This fact was further evidenced by the surface roughness of the bandsaw teeth manufactured by the coated and uncoated teeth of the milling cutter (Fig. 10). The surface roughness of both the rake and clearances faces was reduced. Less friction between the cutter teeth and workpiece can be attributed for the better surface finish in the bandsaw teeth manufactured by the coated teeth of the milling cutter.

Fig. 9. Bandsaw cutting edges formed by the (a) TiN coated and (b) uncoated teeth of the half-length coated milling cutter

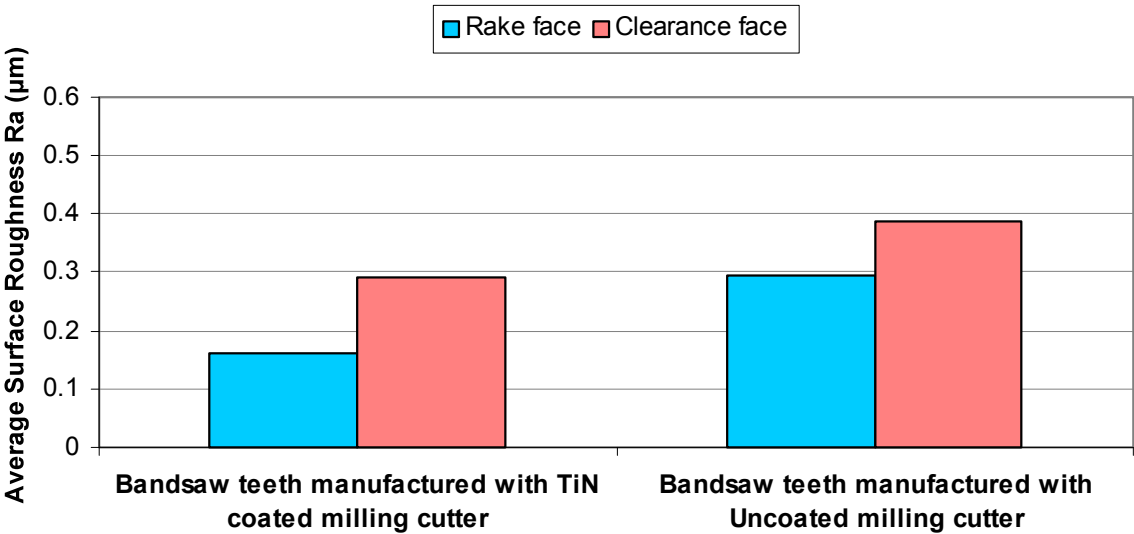
Figure Number: 10

Fig. 10. Average surface roughness of bandsaw cutting edges formed by the TiN coated and uncoated teeth of the half-length coated milling cutter
